Manhole Inspection Summary

Manhole # S31GG2010MH

Insp Date: **12/20/06 2:23 PM**

Location Address: **5812 MEADOWOOD RD**

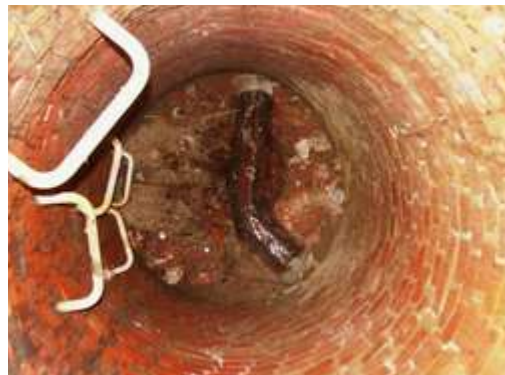
Top View

Evidence of surcharge - Bench debris.

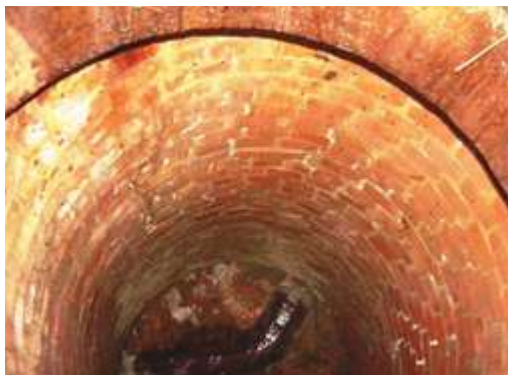
Defect

Adjustment, Corbel, and Barrel infiltration.

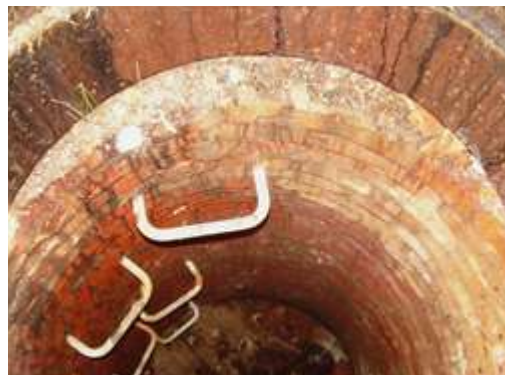
Defect

Frame offset. Adjustment deterioration, root intrusion, and infiltration. Corbel and Barrel infiltration - other side.

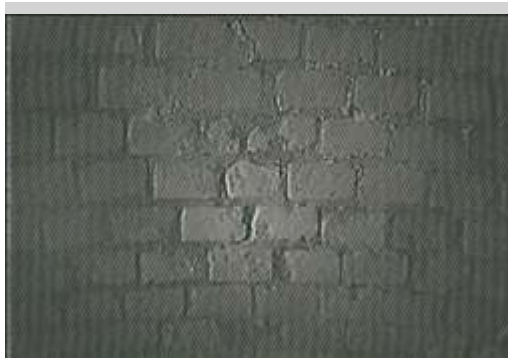
Defect

Barrel infiltration.

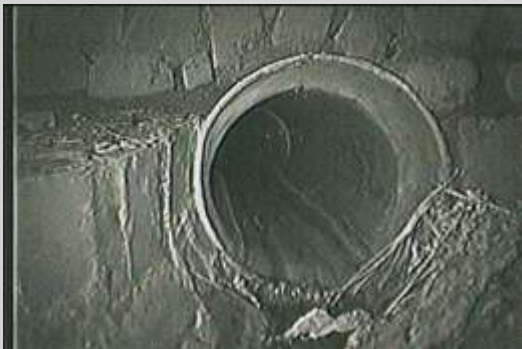
8 in. Circular Gravity Sewer Pipe In @ 5 O'Clock

Channel root intrusion.

Infiltration: **None** Pipe Seal Cond: **Roots**
